# Eurasian Watermilfoil in Lake Leelanau

## Report on Field Activities in 2021

**Lake Leelanau Lake Association  
PO Box 123, Leland, MI 49654**

**Grand Traverse Band of Ottawa and Chippewa Indians  
2605 N. West Bay Shore Dr. Peshawbestown, MI 49682**

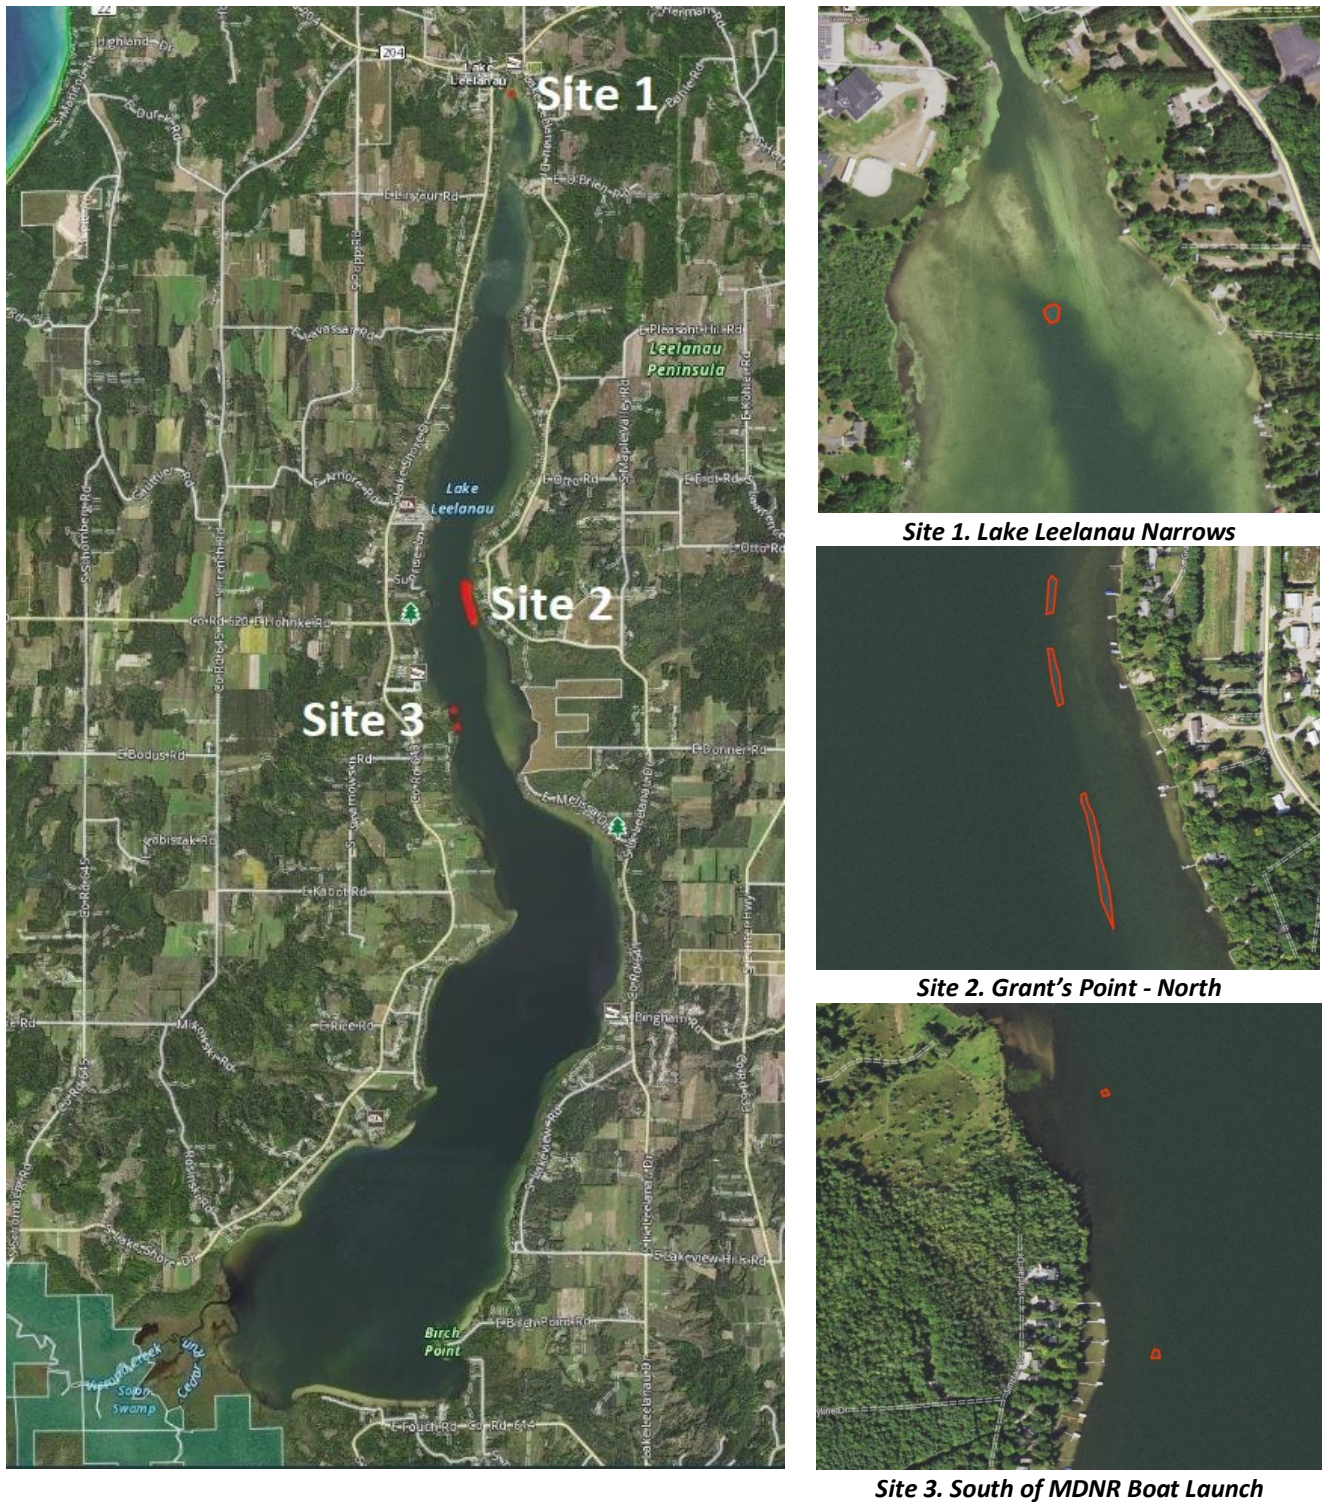
**Figure 1. South Lake Leelanau 2021 Benthic Barrier Locations**

Following submission of documentation on proposed barrier sites to EGLE and the arrival of burlap material on July 28, barrier deployment began on July 29. Over the next week about 1.1 acres of burlap barrier was placed on EWM beds. Sites included three large infestations south of Grant's Point and a site immediately south of the Lake Leelanau Narrows (Figure 1). Two relatively small barriers were also placed about ½ mile south of the DNR west side boat launch in Centerville Township. Because these barriers were deployed late in the season, when EWM plants had in some cases grown nearly to the surface, care was taken to weigh the barriers down with extra re-rod and sandbags, a process that was finished by mid-August.

Despite the late start and short time-frame (only four days for barrier deployment), significant improvements were made in the efficiency and targeting of barriers. In particular, 20ft pieces of ½” re-rod were used to spread each barrier to its full 30ft width, eliminating the need for side anchors. Attached at intervals of approximately 50ft, the re-rod allowed for deployment without stopping to set

During the course of the summer, scouting for new infestations was conducted over virtually the entire littoral zone of both North and South Lake Leelanau. North Lake Leelanau was primarily scouted by volunteer Jim Wysor along with other volunteers, while South Lake Leelanau was scouted on multiple occasions by Brian Price and Ron Reimink. In almost all cases, newly discovered EWM infestations were hand-pulled within weeks in an attempt to stop the spread of EWM to new areas (Figure 1).

New infestations were found about ½ mile south of Fountain Point, on the western shore opposite and southward from Fountain Point, in the Narrows channel, and a couple of very small infestations near Skeba Point on the western shoreline. With the exception of one larger infestation (1/2 mile south of Fountain Point), all of the known new locations were hand-pulled in 2021 within a week or two of discovery (Figure 1).

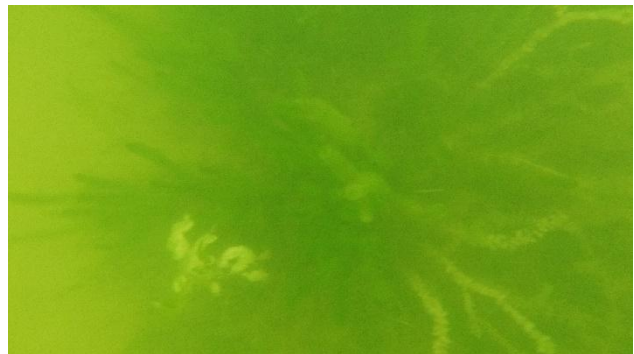
As the season progressed, some barriers experienced more rapid regrowth of plant life established on top of the barrier. Importantly, EWM was not observed growing up through the weave of the barrier material, but rather EWM became established apparently by fragments that landed on the barrier, sending out roots that went down through the burlap into sediments below. Native plants, including Naiads and Pondweed species, also established themselves on the barriers, often in folds or troughs where plant fragments collected.

***Photo 2. Burlap barrier with abundant re-colonization.***

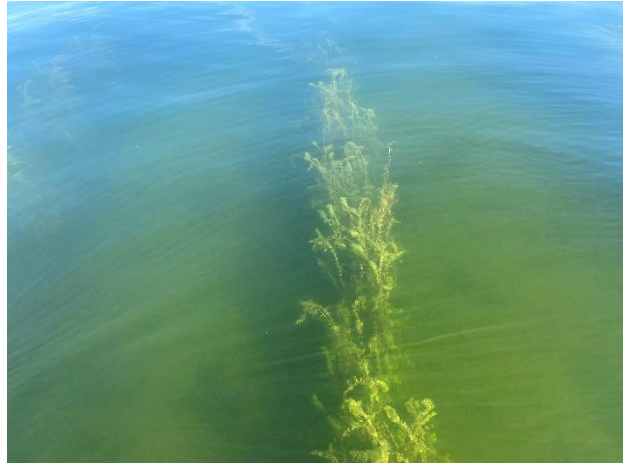
Twice during the course of the summer divers hand-pulled EWM from barriers at the Gordon's Point area. Even within this area, considerable variation in the rate of recolonization was observed. The south end of this large barrier assemblage attempted to cover an EWM bed that was estimated to be 70-80ft wide with a combination of synthetic LBBs along the eastern flank with an adjacent 40ft wide burlap barrier set in deeper water. Both types of barriers killed the target plants below them, but gaps between the barriers and along both the shallow and deep edges produced significant EWM colonies.

**Photo 3. EWM growing in gap between Synthetic Lake Bottom Blankets (LBBs).**

Two divers spent about 2 hours on the southernmost 16,000ft<sup>2</sup> barrier on June 27, removing an estimated 40lbs of EWM. By contrast, the northernmost barriers remained nearly free of EWM, and plants found on the barrier were removed in less than an hour on two occasions.

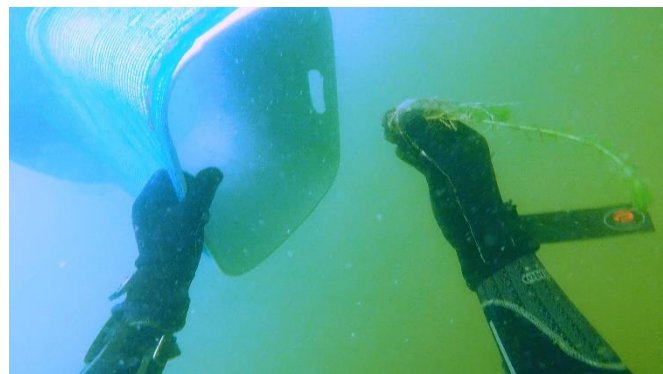
***Photo 3. SCUBA diver hand-pulling EWM.***

Where broad, relatively shallow areas (~6-12ft) provide suitable habitat for EWM to establish across a wide area, transects were run back and forth with a spotter on the boat. A GPS was used to maintain a distance of about 50ft between transects. This was done twice in St Mary’s Bay (just south of the Narrows), once in North Lake Leelanau (just north of the Narrows), and in Paradise Cove in the far SE end of the lake. Two new but very small infestations were found in St. Mary’s Bay and hand-pulled within days. A somewhat larger and scattered infestation was discovered in Paradise Cove and hand-pulled by divers the following week.

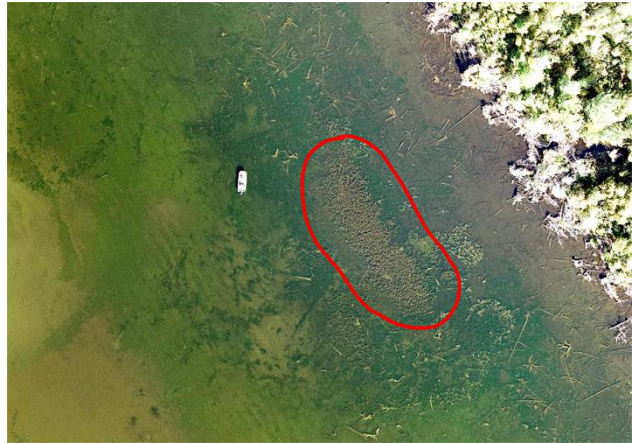
The ortho-mosaic image is produced using image recognition software that assembles multiple digital photos captured in a predetermined autonomous flight path. The image produced is geo-rectified and allows for precise placement when uploaded to mapping programs. ZGA has been awarded a patent by the U. S. Patent and Trademark Office for the adaptation of this process to aquatic venues.

***Photo 4. Aerially documented EWM colony near Mebert Creek***

A limited area of the lake, generally within about ¼ mile of existing barriers, was flown and photographed by ZGA on September 28, 2021. The ortho-mosaic images were reviewed by the partners and Dennis Wiand, owner of ZGA, on three occasions. The consensus is that this technique shows great promise in mapping known infestations, planning treatment, and for locating new infestations.

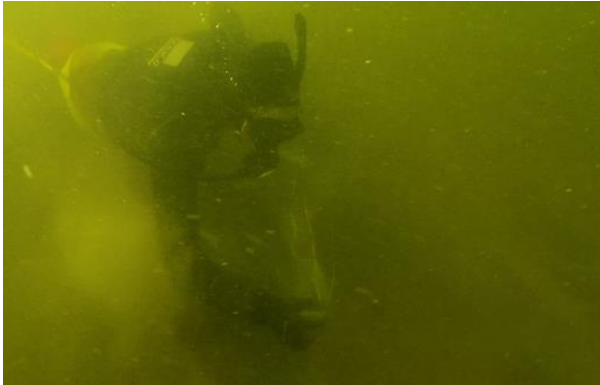
In 2021, field crews transplanted native aquatic plants from higher density beds in close proximity to restoration areas. Native plantings were prioritized in 2020 barrier control areas where monitoring efforts documented less than 25% native plant presence. Where surveys documented the re-establishment of plants in 25% or greater of the photos taken, then natural re-colonization was assumed to be already occurring from surrounding founder colonies. Species transplanted included various Potamogeton species, Vallisneria and Elodea, all of which are abundant in Lake Leelanau and were noted in areas surrounding treatment sites. Plantings were done using two primary methods, from stem fragments (or root-less Chara) deployed from the boat and by using bare roots and/or tubers planted by a scuba diver.

*Photo 5. Planting of rooted plants with SCUBA divers.*

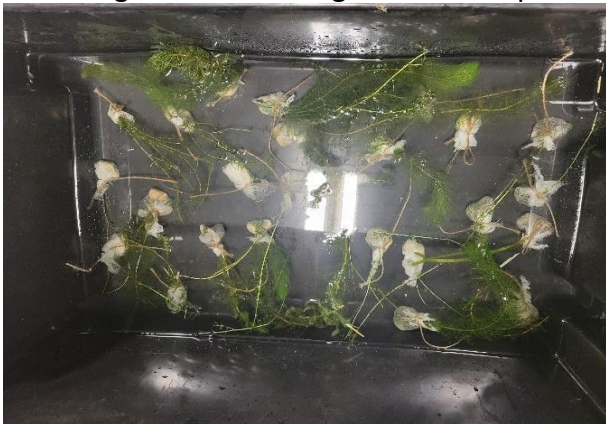
*Photo 6. Weighted stems prepared for deployment.*

Stem fragments or cutting from stem tips have been successfully propagated and planted with pond-

-weeds and Elodea. Stem tips were cut in lengths of 4 to 8 inches, wrapped in burlap or cheesecloth with soil, weighted with small rocks, tied off with twine and deployed from the boat over restoration areas. Bare roots and tubers were harvested, stored in water and planted via scuba diver in at least 3 inches of substrate.
