Eurasian Watermilfoil in Lake Leelanau

Report on Field Activities in 2020

Lake Leelanau Lake Association
PO Box 123, Leland, MI 49654

Grand Traverse Band of Ottawa and Chippewa Indians
2605 N. West Bay Shore Dr. Peshawbestown, MI 49682

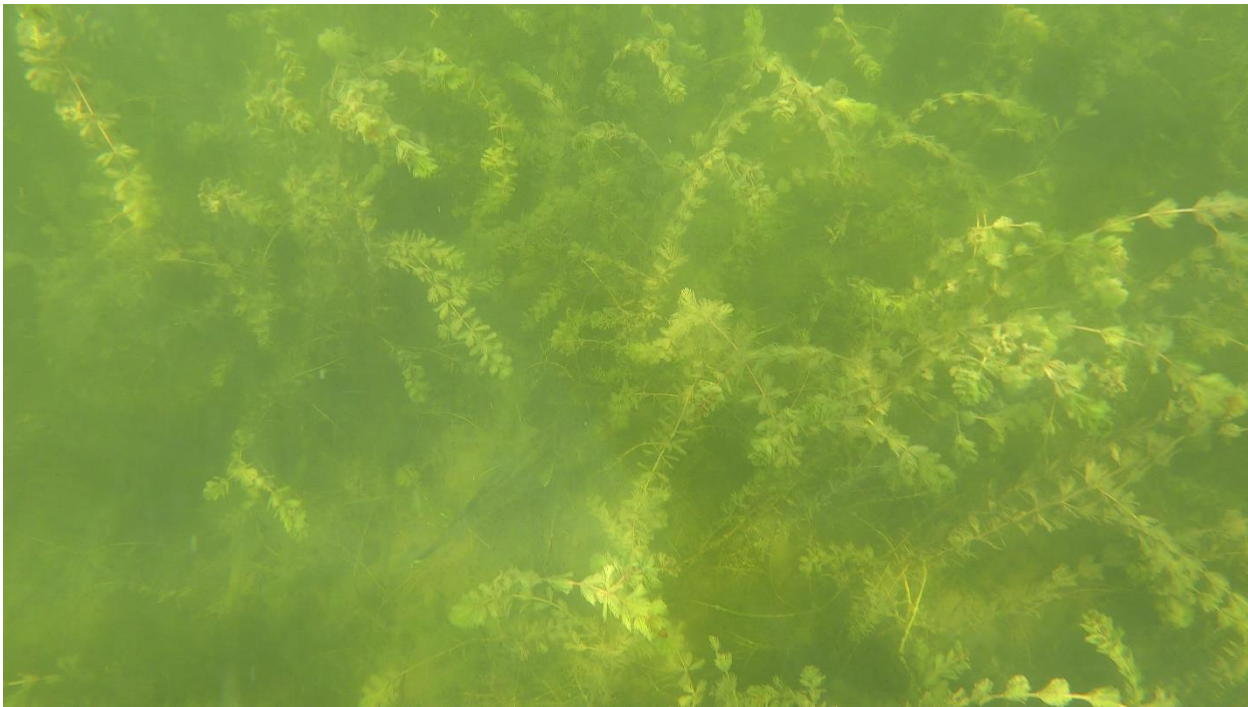
Photo 1. Dense Eurasian Watermilfoil bed captured via scuba diver with attached GoPro.

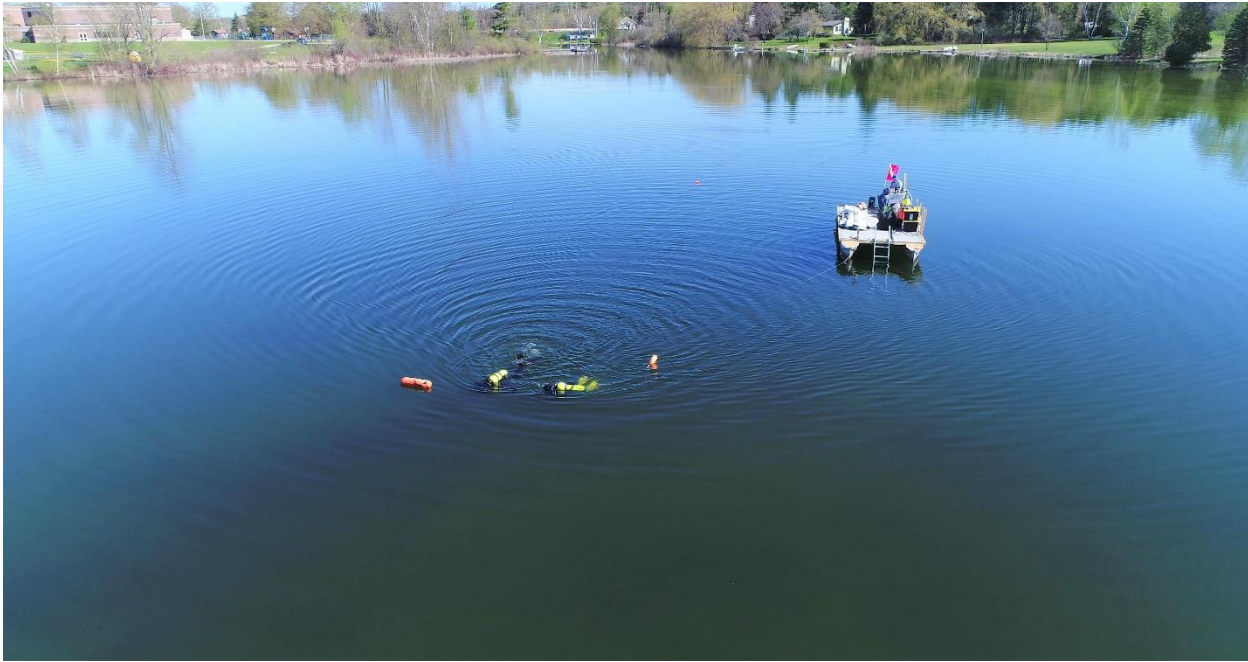
Photo 2. Scuba divers marking Eurasian Watermilfoil beds for benthic barrier deployment.

Sites for burlap barriers were scouted and marked using multiple small buoys (poolies) a day or two prior to deployment. Since barriers were 400 feet long, we were looking for infestations of EWM that were at least 40 feet wide and running in a relatively straight line along a bank for at least 400 feet. There were two such locations in Lake Leelanau about a mile apart.

- 3) Use of barriers is dependent on careful scouting and marking of EWM locations. We were able to set barriers with precision once locations were carefully marked by buoys ("poolies"). There is some very limited ability to "wiggle" long barriers to follow an EWM bed that is not quite straight, but in general, deviating more than 10 or 20 feet from the course of the headline was very unlikely.

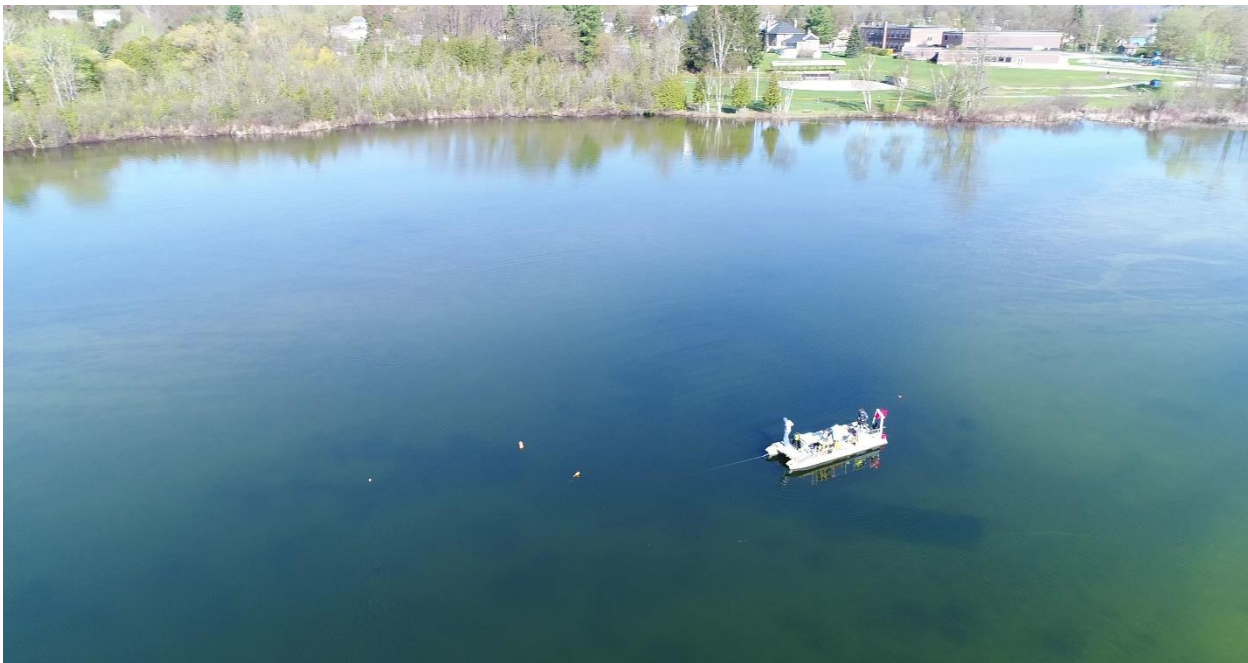
Photo 3. Lake Bottom Blankets (deployed to the right of the boat).

Lake Bottom Blankets were deployed early in the summer over high-priority known infestations beginning with seven LBB's placed on a medium sized EWM bed just south of the Lake Leelanau Narrows. This site, due to its proximity to the boating channel to North Lake Leelanau, and its protected location on windy days, was chosen for initial treatments with

Sets of multiple LBBs proved successful over larger beds of EWM. Up to 12 LBBs were tied together in a double wide "gang." Nylon cord

and/or zip ties were used to attach the LBB's together. Such a gang could be up to 240 feet long and 20 feet wide. The size again was limited by the weight our boat could handle. Similar to setting individual LBB's, we first carefully marked the location of the EWM bed, but when setting larger gangs, a "head-line" was set directly over the area we intended to cover, anchored on each end by 50 lb trap net anchors. Once the "head-line" was set, the boat returned to end of the EWM bed, pulled up the head-line, and replaced the line with the "gang" of LBBs. In one instance we loaded and set a 12 LBB gang in the morning, tied onto it, and set an additional 10 LBB gang in the afternoon. In that instance, our crew was able to deploy barriers that eradicated an area of 0.2 acres of EWM in a day's work.

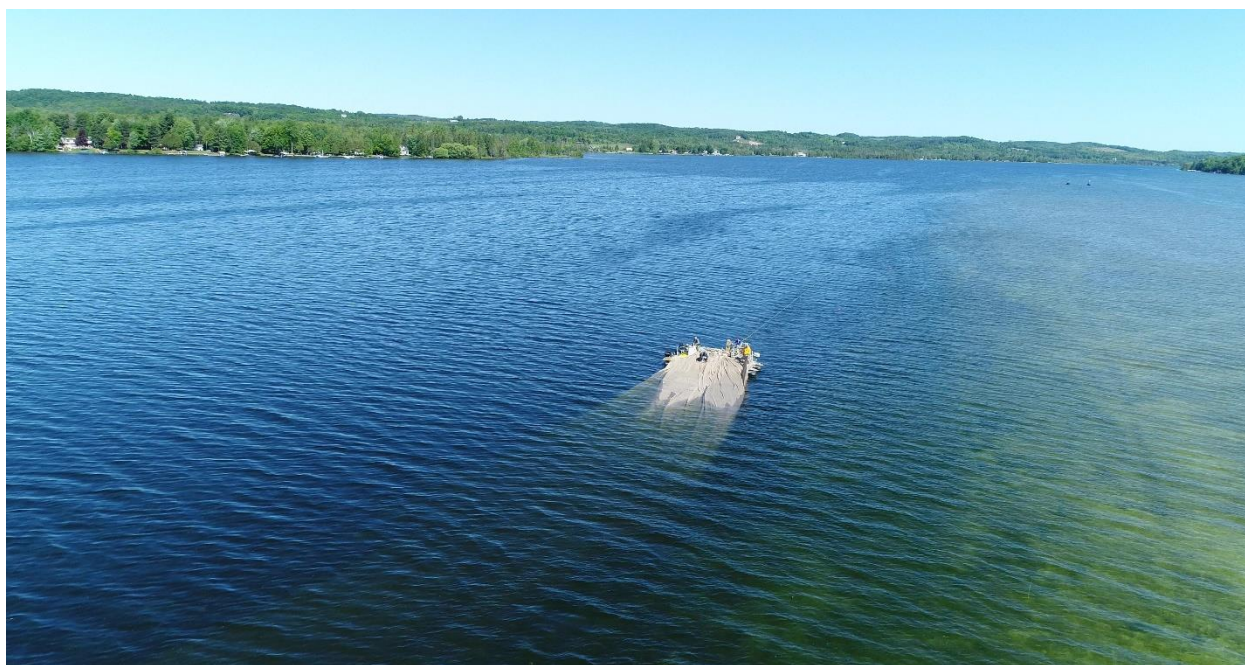
Photo 4. Burlap Barriers.

Burlap Barriers were much larger than the Lake Bottom Blankets and are biodegradable. To our knowledge no one had ever set such large barriers underwater for the purpose of killing aquatic invasive plants, so we had to invent techniques to deploy the barriers. Methods to hold the barriers in place using anchors and sandbags were adapted based on work by Chadderton and Tucker (2017) in southern Michigan lakes.

Burlap Barriers were set using the same modified commercial fishing technique that had been employed for setting "gangs" of LBB's tied together. The head line was set over the middle of the EWM bed, running parallel to the bank, with about 100 feet left over at each end. Once the head-line was set and in position, the boat returned to the approximate location where the barrier set would begin, pulling the line up and across the boat using a buoy that had been attached for that purpose. The beginning location of the barrier set can be

The burlap barrier set ended when all the material was off the boat. The corners were again anchored, and the head line anchors stayed in place to keep considerable tension on the barrier along the length of the set. In good weather a barrier could be set in about 90 minutes. We were able, on two occasions, to return, reload, and set a second barrier in a single day. Altogether, 5 burlap barriers were placed in the lake, covering about 1.8 acres.

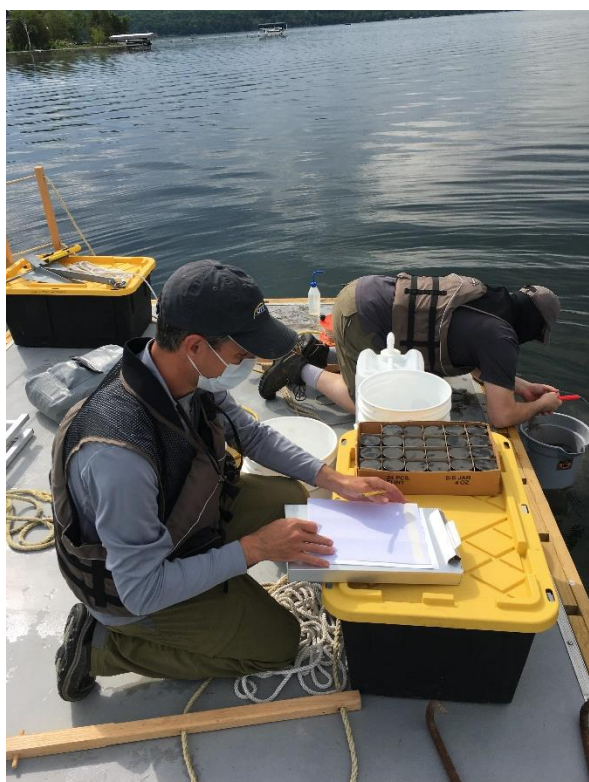
Photo 5. GTB biologist collecting macroinvertebrate samples.

Prior to deployment of barriers, personnel from GTB collected plant and sediment samples at

at locations where we expected to set barriers. Some of those locations ended up receiving barriers, while others ultimately did not. Regardless, these samples, when analyzed will help to establish a baseline for benthic communities in Lake Leelanau. Additional samples near areas where barriers were deployed should be taken in 2021 as well. Sediment and plant samples were also taken after Lake Bottom Blankets were removed at three different locations. No live plants were found at these locations, as expected. Beginning on July 22 (3 weeks after the last burlap barrier was set) and continuing on 8/5, 8/19, and 9/24 sampling was conducted below the burlap barriers in two locations near Gordon's Point. On each sample location a 1-meter square was cut from the burlap, and photos along with vegetation and sediment samples were taken. This sampling should be repeated at appropriate intervals in 2021.
