**2017 Data Report  
for  
North Lake Leelanau, Leelanau  
County**

Site ID: 450236

# North Lake Leelanau, Leelanau County 2017 CLMP Results

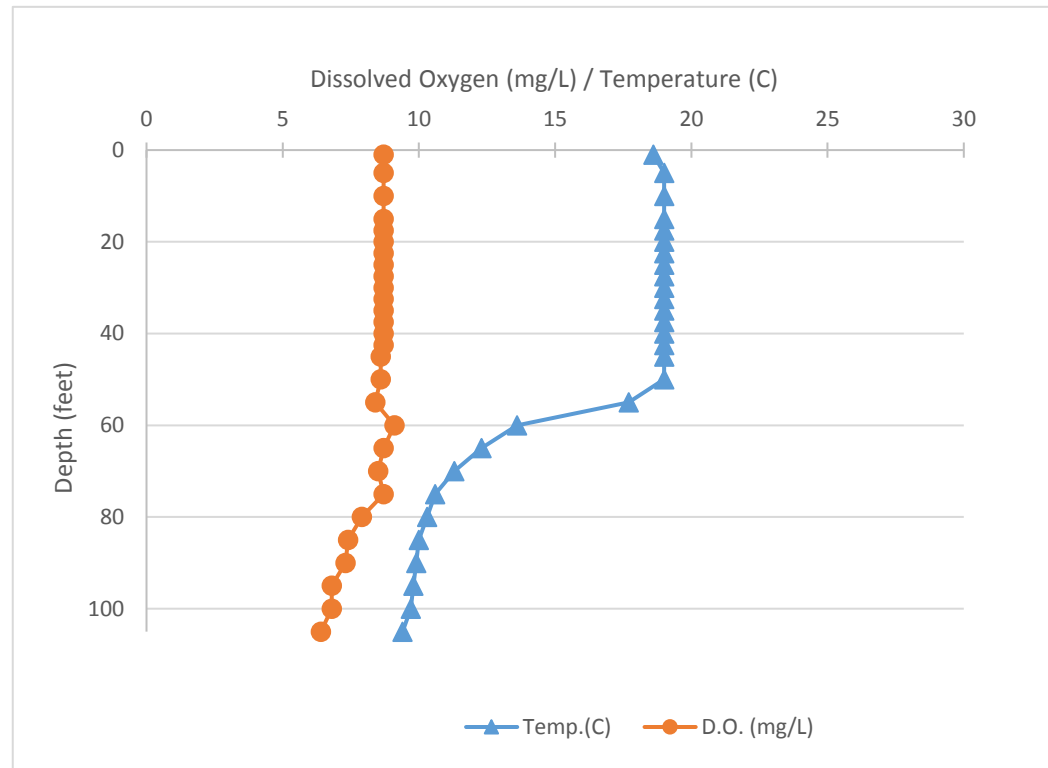
9/7/2017

Depth (ft)	Temp.(C)	D.O. (mg/L)
1	18.6	8.7
5	19	8.7
10	19	8.7
15	19	8.7
17.5	19	8.7
20	19	8.7
22.5	19	8.7
25	19	8.7
27.5	19	8.7
30	19	8.7
32.5	19	8.7
35	19	8.7
37.5	19	8.7
40	19	8.7
42.5	19	8.7
45	19	8.6
50	19	8.6
55	17.7	8.4
60	13.6	9.1
65	12.3	8.7
70	11.3	8.5
75	10.6	8.7
80	10.3	7.9
85	10	7.4
90	9.9	7.3
95	9.8	6.8
100	9.7	6.8
105	9.4	6.4
